5 Rail Vibration Measurement Results and Assessment

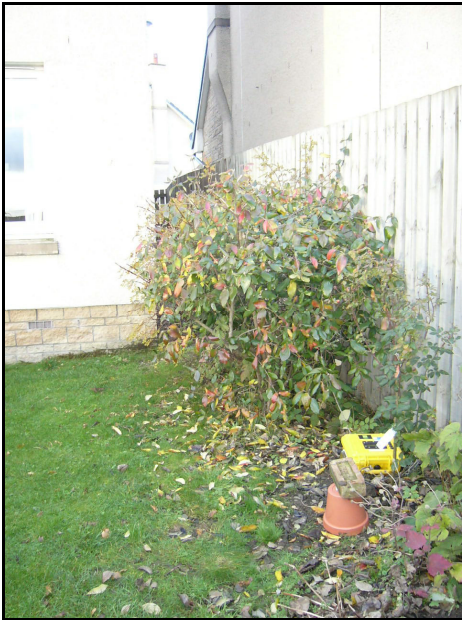
Figure 5.3: Photograph of Vibration Monitoring Equipment at 10 Craiglea, Causewayhead

- 5.6 The measurement transducer was located approximately 12 m to the north of the nearside of the SAK Railway line and approximately 4 m to the south of the façade of 10 Craiglea. Figure 5.3 shows the equipment with the dwelling to the left.

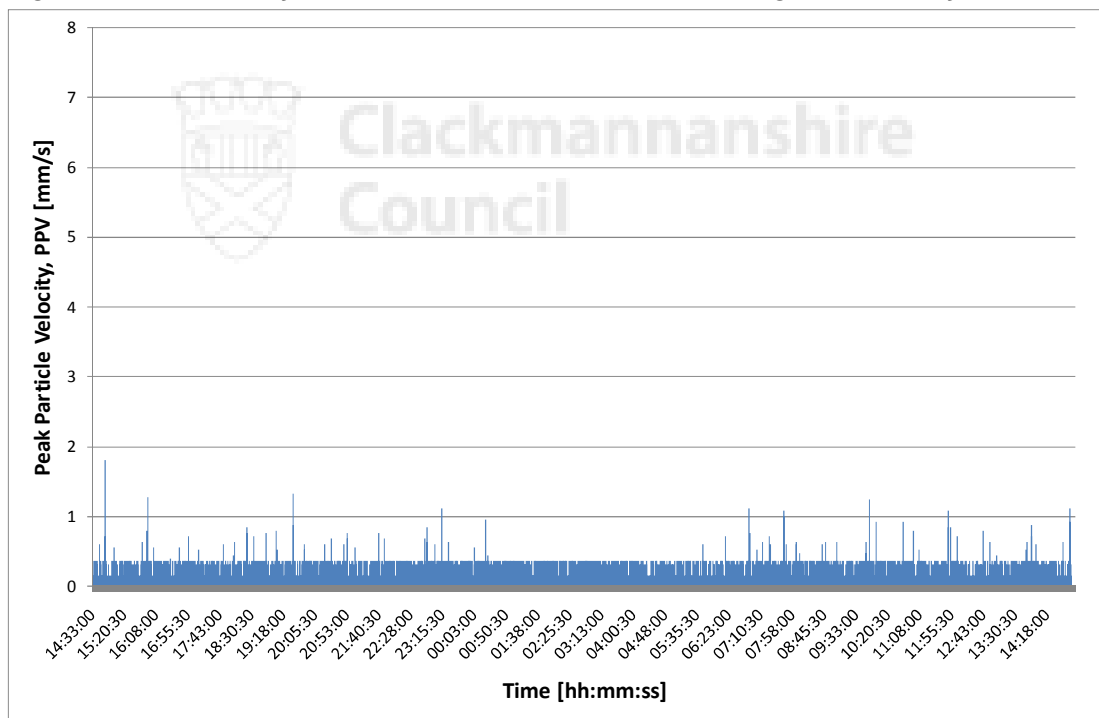
Figure 5.4: Time History of 30-Second PPVs Measured at 10 Craiglea, Causewayhead

- 5.7 The weather conditions during the measurement period are believed to have been generally dry with very light winds. It is possible that there was a light ground frost at night.
- 5.8 Figure 5.4 shows the time history (in 30 second samples) of the measured PPVs. A series of peaks can be seen to rise above a very consistent background level. The latter is the aforementioned system noise floor. The tallest peaks are likely to correspond with freight trains. The peaks of lower level are likely to correspond with scheduled passenger services. It can be seen that there was no rail traffic during the night. Other sources of vibration, such as road traffic, are not significant.

- 5.9 The highest measured PPV was 1.807 mm/s. This level occurred between 14:51:00 and 14:51:30 on Wednesday 24th November. It is likely to have resulted from the passage of a freight train.
- 5.10 The measured PPVs are well below the criteria in BS 7385. This is even when it is assumed that dynamic magnification occurs, as described in 3.6. It is therefore unlikely that cosmetic structural damage to the dwelling might result (or might have resulted) from train pass-bys. The likelihood of more profound structural damage is very low. Any apparent structural damage, such as cosmetic cracks not previously reported in 2005, is unlikely to have resulted from rail vibration.

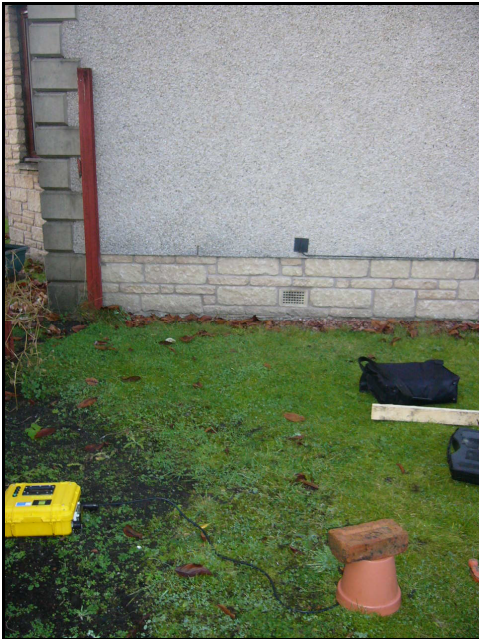
Figure 5.6: Photograph of Vibration Monitoring Equipment at Colum-Cille, Hilton Road, Alloa

- 5.13 The measurement equipment was located approximately 11 m to the north of the nearside of the SAK railway line and approximately 3 m to the south of the facade of Colum-Cille, Hilton Road. Figure 5.6 illustrates.

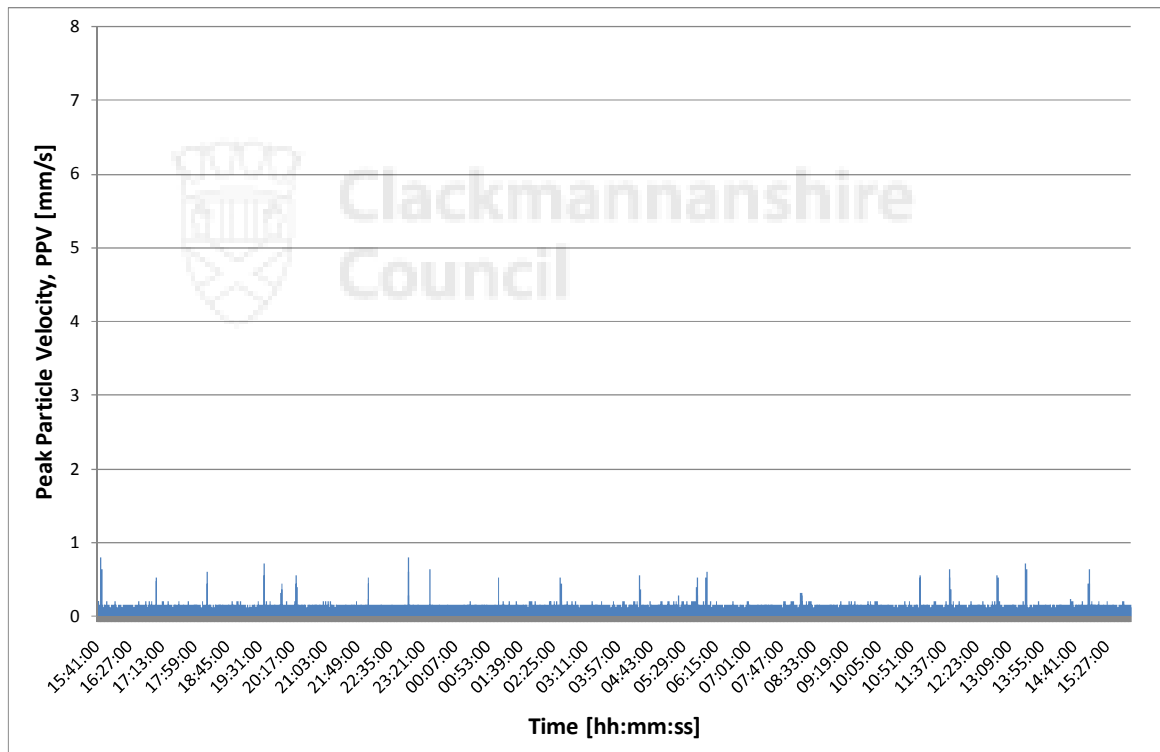
Figure 5.7: Time History of 30 second PPVs Measured at Colum-Cille, Hilton Road, Alloa

- 5.14 It is believed to have rained intermittently during the measurement period. Winds were relatively high on the Friday afternoon, but by Monday these had reduced to a fresh breeze.
- 5.15 Figure 5.7 shows the time history (in 30 second samples) of the measured PPVs. The peaks are likely to correspond with freight train pass-bys. Other sources of vibration, such as road traffic, are practically insignificant.

- 5.16 The highest measured PPV was 0.924 mm/s. This level occurred between 09:26:30 and 09:27:00 on Monday 22 November.
- 5.17 The measured PPVs are well below the criteria and are therefore unlikely to give rise to structural damage of any kind.
