### 20 Ladywood, Clackmannan, Clackmannanshire

### 18 Ladywood, Clackmannan, Clackmannanshire

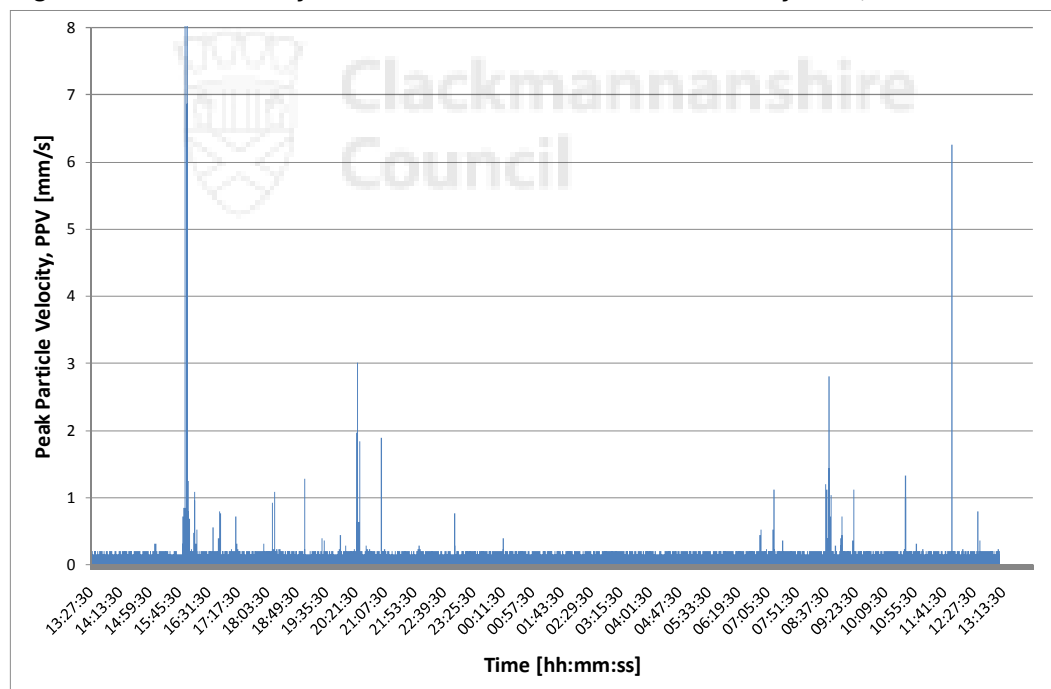
**Figure 5.28: Time History of 30 second PPVs Measured at 30 Ladywood, Clackmannan**

- 5.57 The weather conditions during the measurement period are believed to have been generally dry with very light winds. There may have been a light ground frost during the night.
- 5.58 Figure 5.28 shows the time history of the measured PPVs. The spacing and relative magnitude of the most significant peaks suggest these were not caused by rail traffic. The highest levels are not consistent with a distance of 36 m to the railway. Levels at 20 Ladywood, at 41 m from the railway, are orders of magnitude lower. It is therefore reasonable to conclude that the significant levels were caused by spurious events such as the attention of children, household pets or tampering. This means that the data is inconclusive.

5.59 The dataset, which is contaminated by spurious events, provides no reliable indication of the PPV from train pass-bys. Vibration from train events can therefore not be assessed with respect to the criteria. Some indication of the likelihood of excessive levels is however provided by the dataset for 20 Ladywood, which shows PPVs below 0.5 mm/s. The risk of adverse structural effects due to vibration is therefore remote.

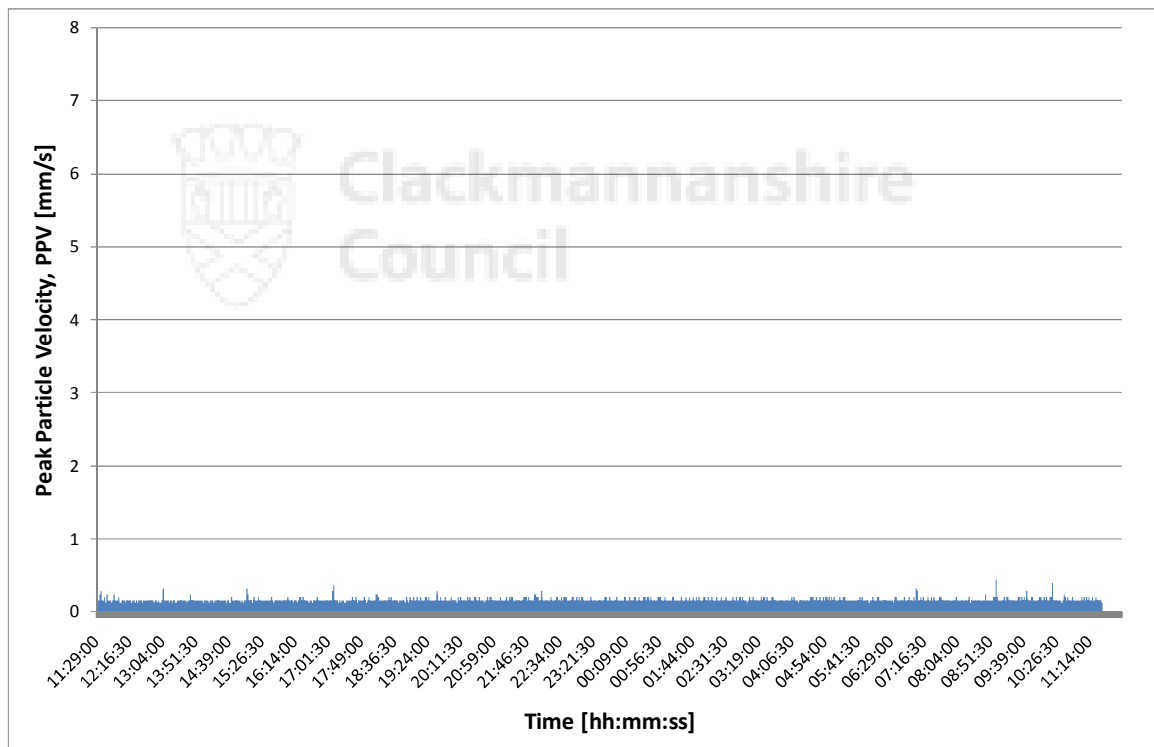
**Figure 5.31: Time History of 30-Second PPVs Measured at 20 Ladywood, Clackmannan**

- 5.63 The weather conditions during the measurement period are believed to have been generally dry with a fresh breeze. During the night-time period it is possible that there was a light ground frost.
- 5.64 Figure 5.31 shows the time history of the measured PPVs. A series of peaks are seen to rise just above the noise floor of the measurement system. These slight increases in vibration are likely to represent the passage of freight trains.

5.65 The highest measured PPV was  $0.442 \text{ mms}^{-1}$ . This level occurred between 08:59:00 and 08:59:30 on Tuesday 23<sup>rd</sup> November. It is likely that this level represents the passage of a freight train. This level is well below criteria.

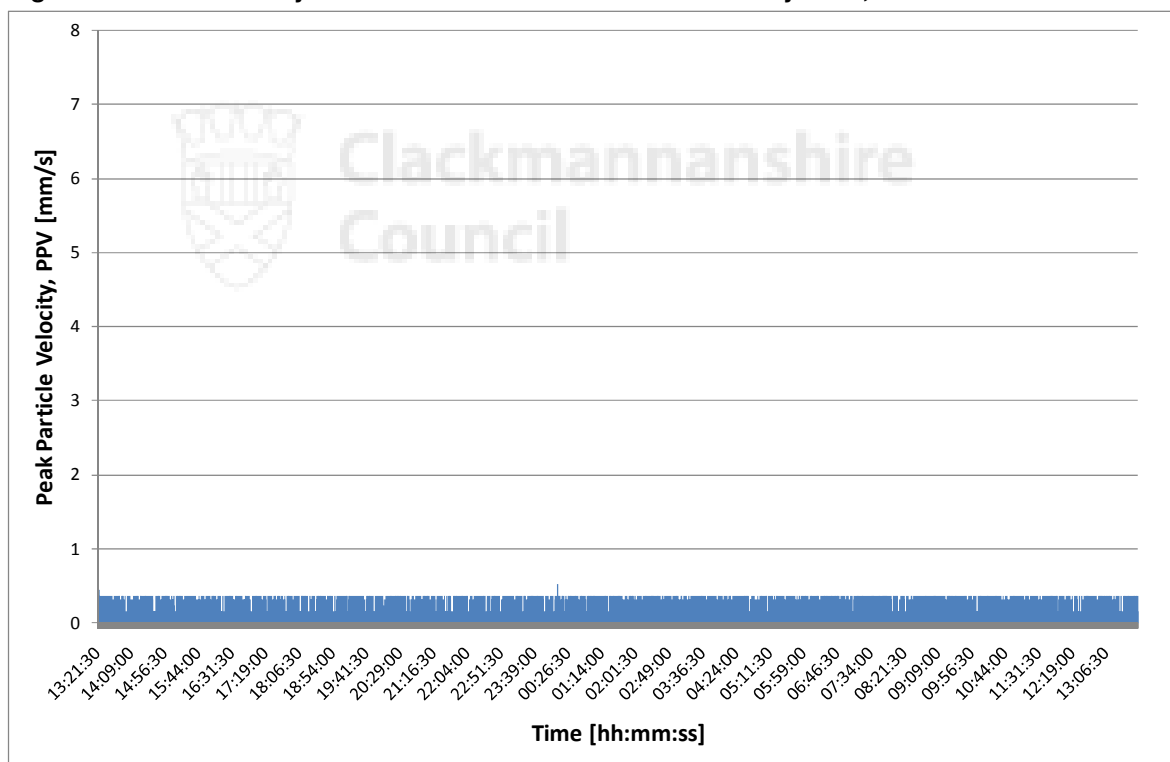
**Figure 5.35: Time History of 30-Second PPVs Measured at 18 Ladywood, Clackmannan**

5.70 Figure 5.35 shows the time history of the measured PPVs. One event can be seen to exceed the noise floor of the measurement system. There is no pattern of regular train pass-bys, so there is little to support the notion that this level is caused by trains. It is most likely a temporary increase in system noise floor.

- 5.71 The highest measured PPV was 0.522 mm/s. This level occurred between 00:11:00 and 00:11:30 on Wednesday 24<sup>th</sup> November. This level, if caused by a train, would be well below the criteria. The possibility of structural damage of any kind is extremely remote.
