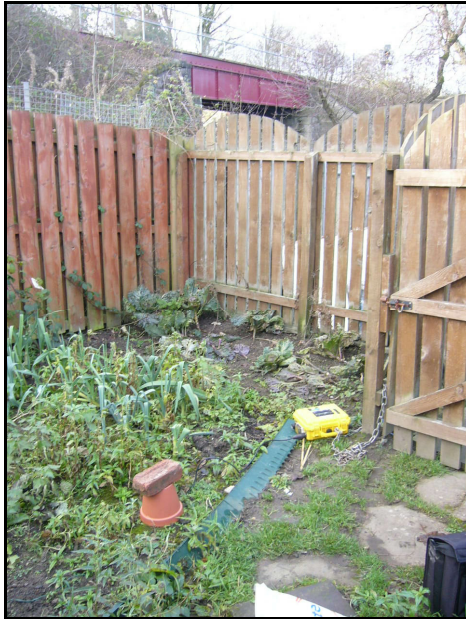
Figure 5.9: Photograph of Vibration Monitoring Equipment at 4 Mill Road, Clackmannan

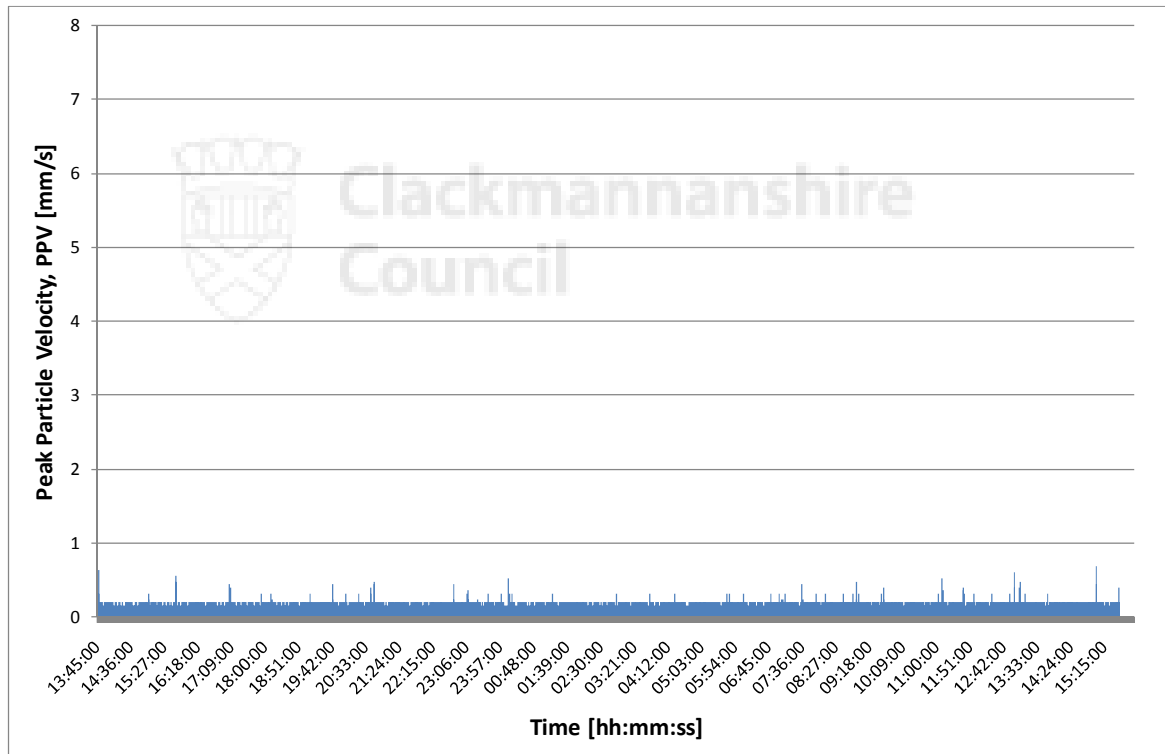
- 5.21 The weather conditions during the measurement period are believed to have been generally dry with very light winds. During the night-time period it is possible that there was a light ground frost.
- 5.22 Figure 5.10 shows the time history of the measured PPVs. The highest peaks are likely to correspond with freight train pass-bys. Lower level peaks are likely to have been caused by sporadic traffic on Mill Road.

Figure 5.10: Time History of 30-Second PPVs Measured at 4 Mill Road, Clackmannan

- 5.23 The highest measured PPV was 0.683 mm/s. This level occurred between 15:01:00 and 15:01:30 on Thursday 25 November. Levels of vibration are well below criteria for structural damage.

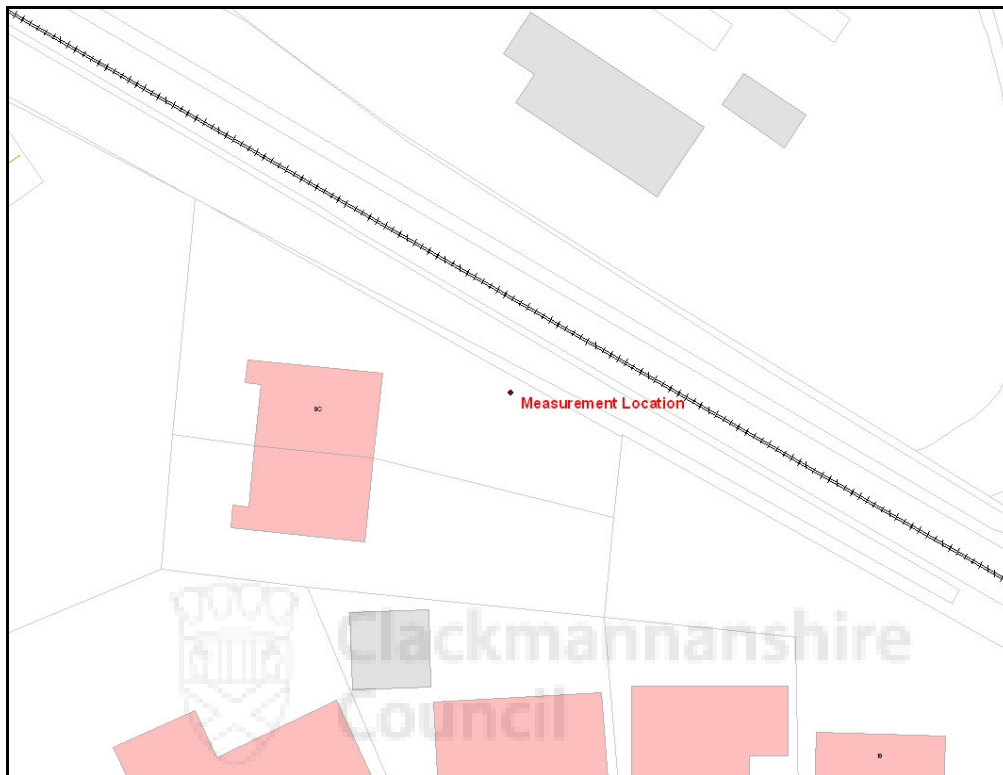
- 5.24 Continuously logged measurements were made from 12:35 on 24 November 2010 until 15:45 on 25 November 2010. For practical reasons, the
- 5.25 Hetherington Drive is a cul-de-sac located off Alloa Road and is therefore unlikely to be heavily trafficked. The SAK line is approximately 0.5-1 m below the ground height at the dwelling. The railway is believed to be the only source of significant vibration within the locale. Figure 5.11 illustrates the measurement location in relation to the surrounding area of the property.

Figure 5.11: Plan of Measurement Location at 8D Hetherington Drive, Clackmannan

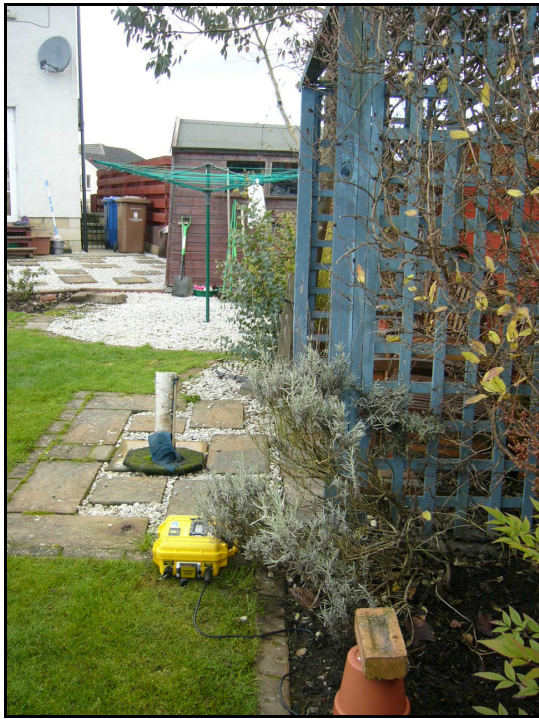
- 5.26 The measurement transducer was located approximately 7 m to the south of the nearside of the SAK railway track and approximately 11 m to the east of the facade of 8D Hetherington Drive. This location, somewhat further from the perimeter of the dwelling than desirable, was chosen for practical reasons. Figure 5.12 illustrates.

Figure 5.12: Photograph of Vibration Monitoring Equipment at 8D Hetherington Drive, Clackmannan

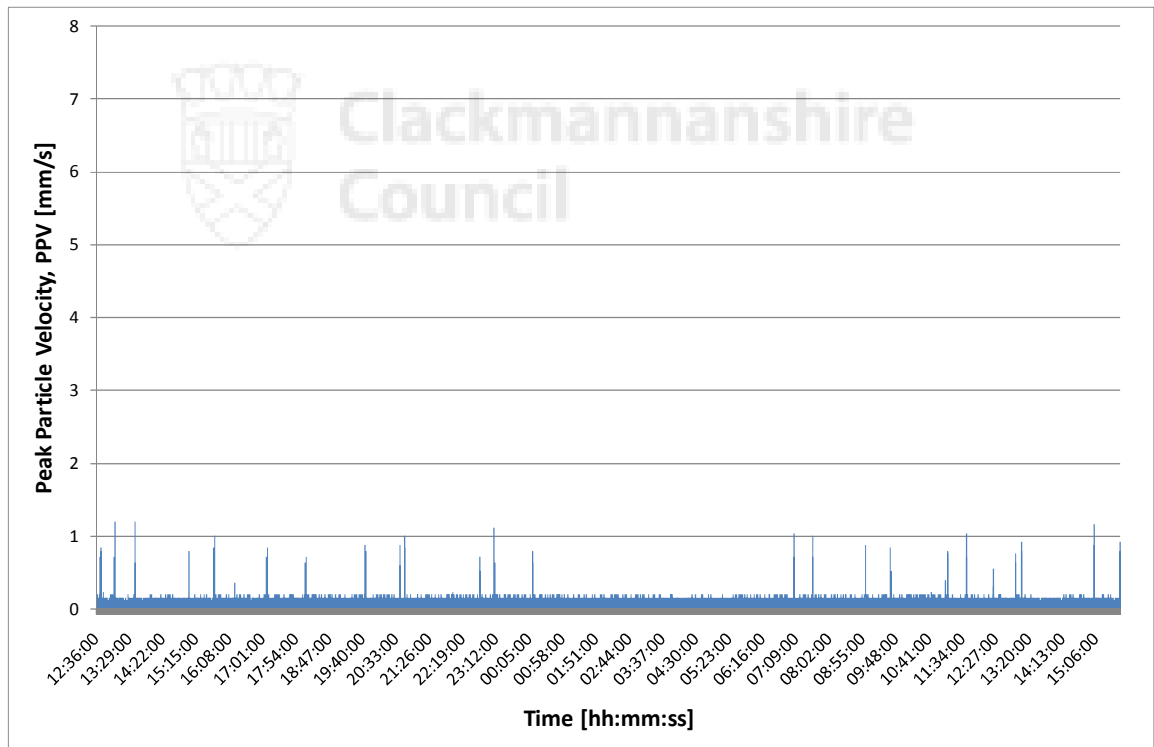
- 5.27 The weather conditions during the measurement period are believed to have been generally dry with very light winds. During the night-time period it is possible that there was a light ground frost.
- 5.28 Figure 5.13 shows the time history of the measured PPVs. All the significant events are likely to represent train pass-bys.

Figure 5.13: Time History of 30 second PPVs Measured at 8D Hetherington Road, Clackmannan

5.29 The highest measured PPV was 1.205 mm/s. This level occurred between 13:04:00 and 13:04:30 on Wednesday 24 November. Vibration is unlikely to give rise to structural damage of any kind.

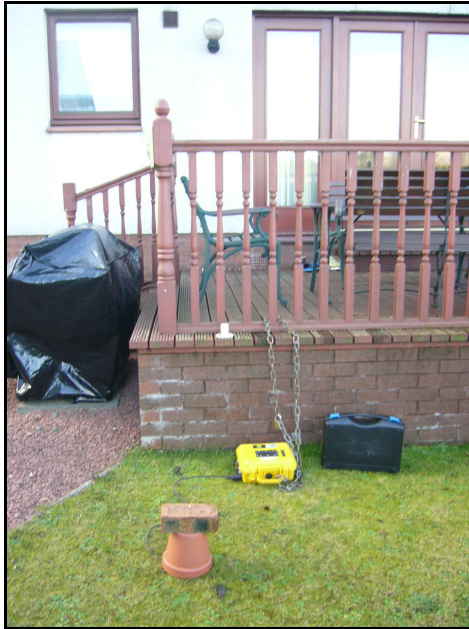
5.32 The vibration transducer was located approximately 16 m to the south of the nearside of the railway track and approximately 5 m to the north of the façade of 25 Brucefield Crescent. See Figure 5.15.

Figure 5.15: Photograph of Vibration Monitoring Equipment at 25 Brucefield Crescent, Clackmannan

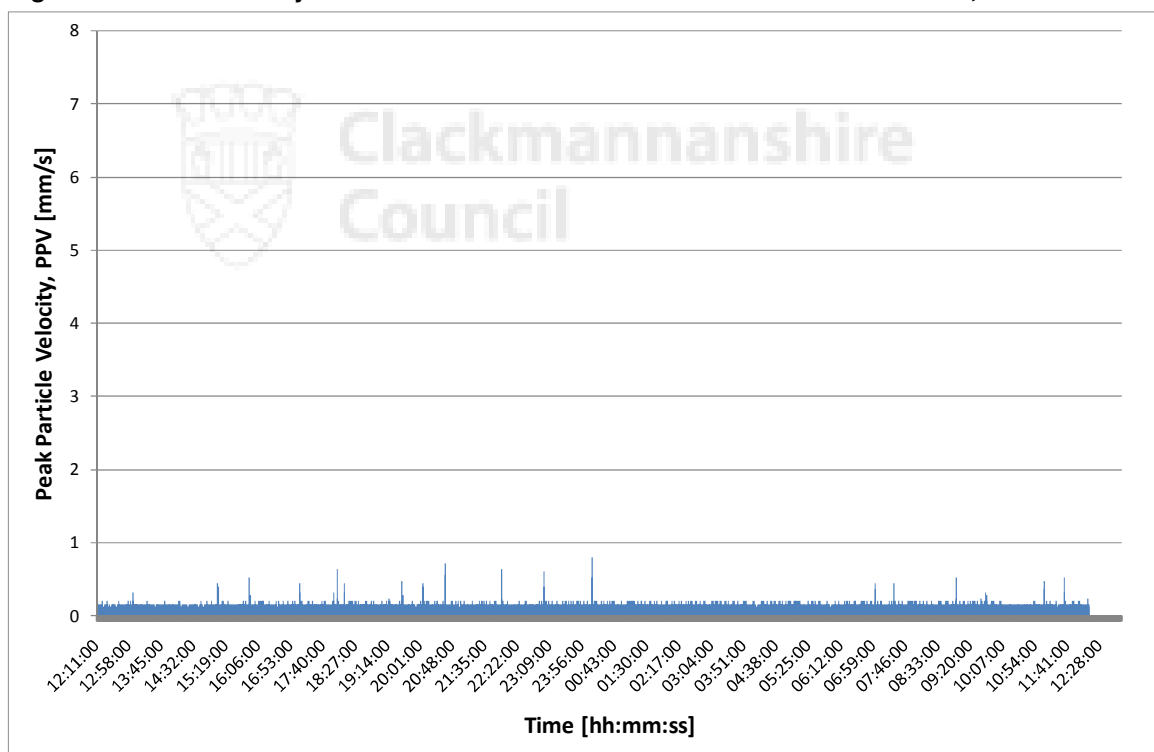
- 5.33 The weather conditions during the measurement period are believed to have been generally dry with very light winds. During the night-time period it is possible that there was a light ground frost. These conditions are unlikely to have affected the measurement results.
- 5.34 Figure 5.16 shows the time history of the measured PPVs. All the peaks of significance are expected to correspond with train pass-bys. They are similar and relatively widely spaced over time, consistent with freight movements.

Figure 5.16: Time History of 30 second PPVs Measured at 25 Brucefield Crescent, Clackmannan

5.35 The highest measured PPV was 0.803 mm/s, which is well below criteria. The level occurred between 00:10:00 and 00:10:30 on Wednesday 24th November. It is highly unlikely that structural damage to the dwelling could result from the measured values.

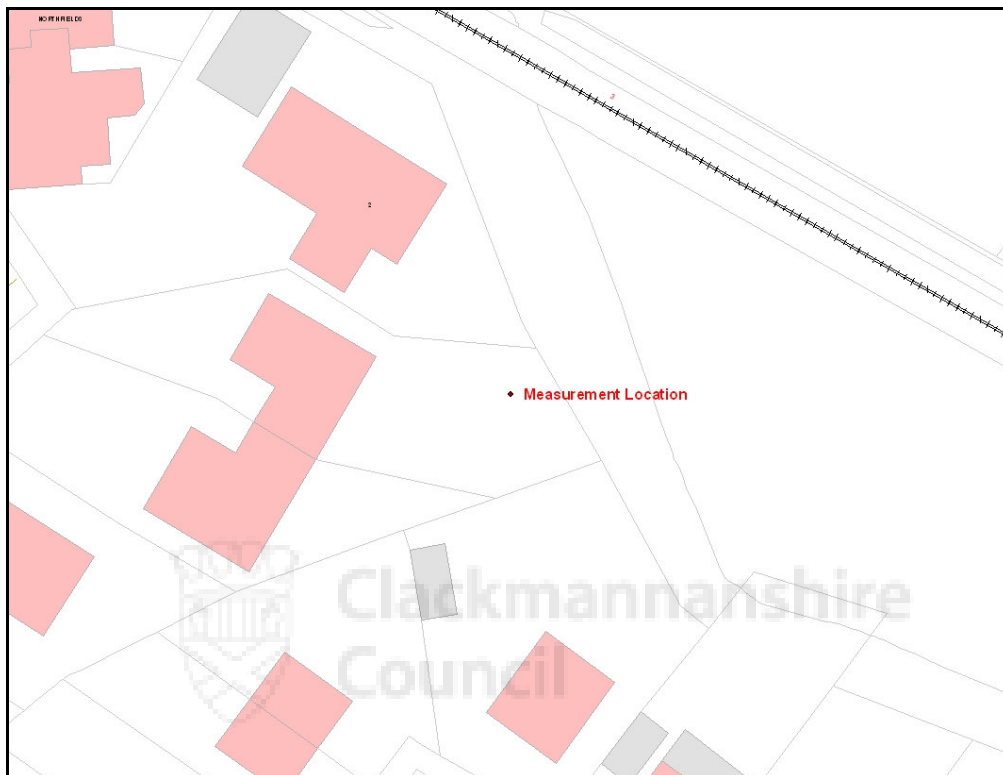
5.37 Northfield Gardens is a cul-de-sac located off Brucefield Crescent. It can therefore be expected to carry very low volumes of traffic. The SAK railway line, which is elevated above the dwelling's garden by around 1 m, is likely to be the only local source of environmental vibration. Figure 5.17 shows a plan of the measurement location in relation to the site.

Figure 5.17: Plan of Measurement Location at 3 Northfield Gardens, Clackmannan
