17 Ochil View, Kincardine, Fife

16 Ochil View, Kincardine, Fife

Station House, Station Road, Kincardine, Fife

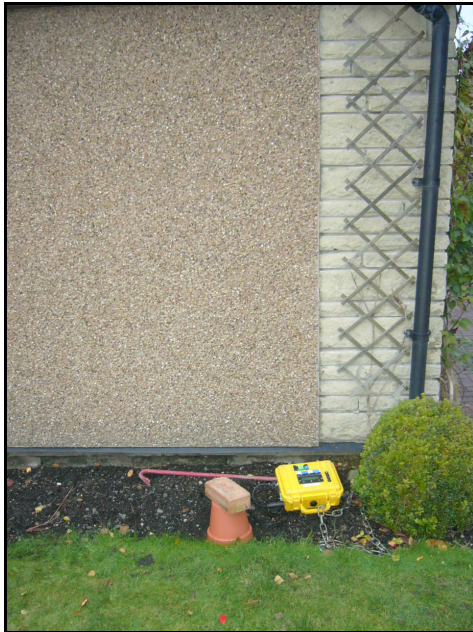
Figure 5.46: Photograph of Vibration Monitoring Equipment at 23 Ochil View, Kincardine

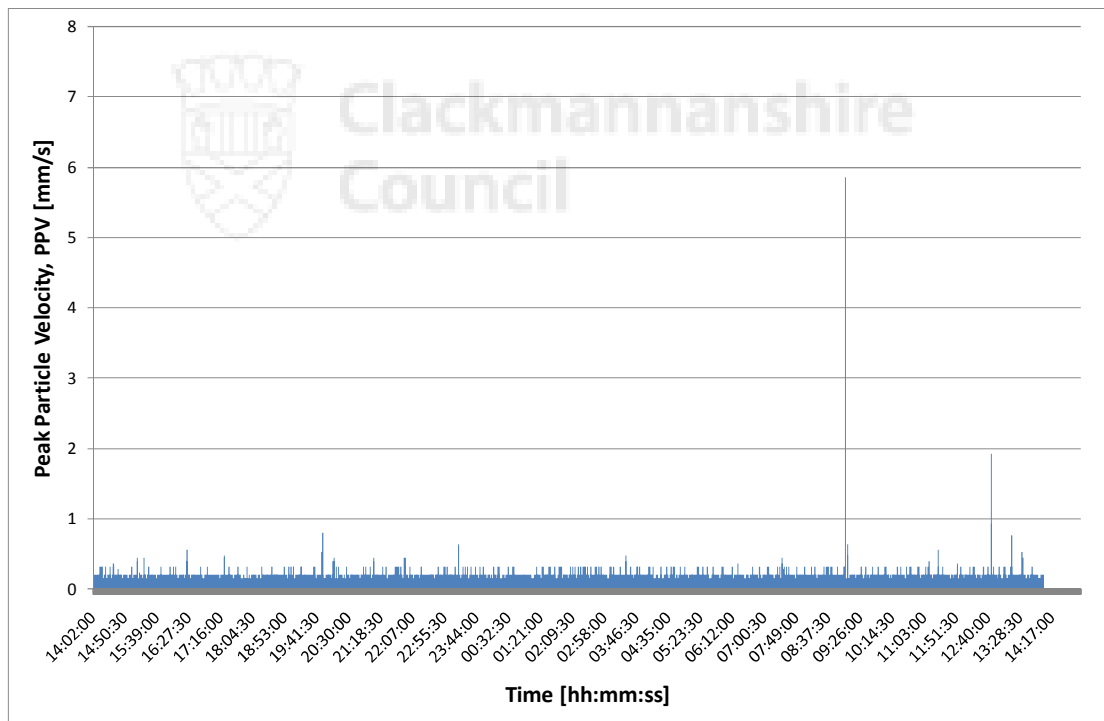
- 5.94 Winds of near gale force are likely to have occurred throughout the measurement period. There is unlikely to have been any precipitation.
- 5.95 Figure 5.47 shows the time history of the measured PPVs. Lower level peaks, around 0.5 mm/s, are likely to correspond with train movements. Two peaks can be seen to rise well above those of the train events. These are likely to be associated with occupant activities. For practical reasons, the measurement transducer was located near the garage of the dwelling, where this activity (e.g. closing of main doors) might have occurred.

Figure 5.47: Time History of 30-Second PPVs Measured at 23 Ochil View, Kincardine

- 5.96 The highest measured PPV was 5.863 mm/s. This level occurred between 09:01:30 and 09:02:00 on Friday 19 November. As noted, this level is likely to be associated with occupant activity. The highest level likely to have resulted from a train pass-by is 0.803 mm/s. This occurred between 19:48:30 and 19:49:00 on the Friday. This level is well below the criteria and so is unlikely to give rise to structural damage of any kind.

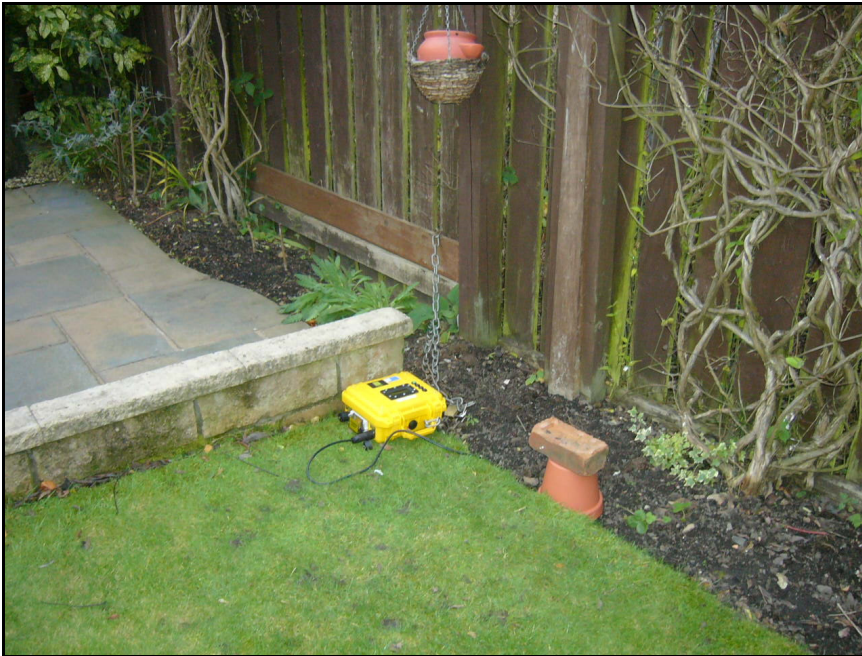
- 5.99 The measurement equipment was located approximately 5 m to the east of the nearside of the SAK railway track and approximately 4 m to the north of the facade of 17 Ochil View. Figure 5.49 illustrates.

Figure 5.49: Photograph of Vibration Monitoring Equipment at 17 Ochil View, Kincardine

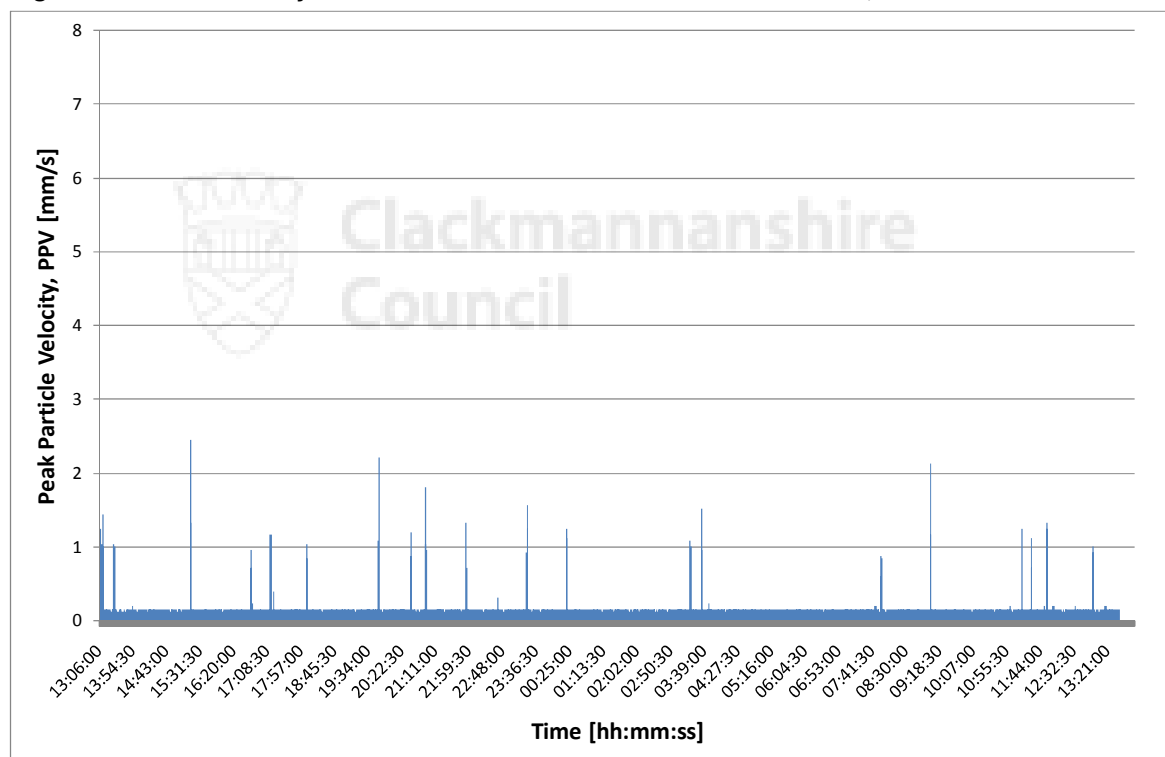
- 5.100 Winds of near gale force are likely to have occurred throughout the measurement period. There is unlikely to have been any precipitation.
- 5.101 Figure 5.50 shows the time history of the measured PPVs. The visible peaks are entirely consistent with train movements, as evidenced by the other datasets.

Figure 5.50: Time History of 30-Second PPVs Measured at 17 Ochil View, Kincardine

- 5.102 The highest measured PPV was 2.45 mm/s. This level occurred between 15:16:30 and 15:17:00 on Wednesday 17 November. Table 3 of this report gives the currently applicable UK criteria for vibration-

induced cosmetic damage to buildings. In the absence of frequency data, it should be conservatively assumed that PPVs should not exceed 15 mm/s. Taking into consideration the influence of dynamic magnification, 50% of this level, or 7.5 mm/s, might give rise to cosmetic damage in unreinforced or light framed structures such as dwellings. The measured value is less than a third of this..It is therefore unlikely to cause any structural damage..

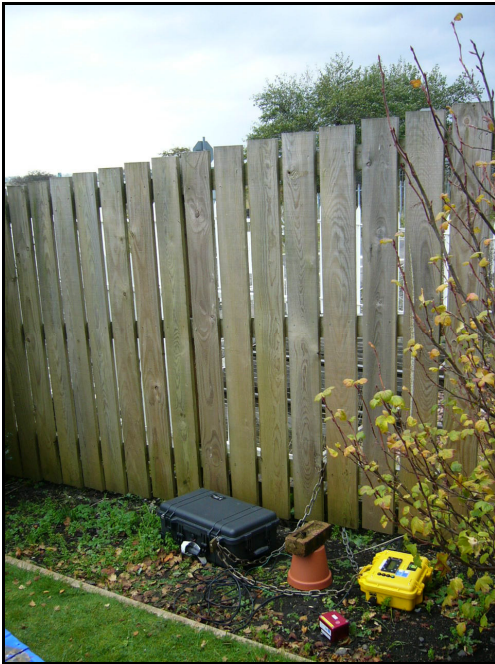
- 5.105 The measurement equipment was located approximately 3 m to the east of the nearside of the SAK railway track and approximately 3 m to the south of the facade of 16 Ochil View. Figure 5.52 illustrates.

Figure 5.52: Photograph of Vibration Monitoring Equipment at 16 Ochil View, Kincardine

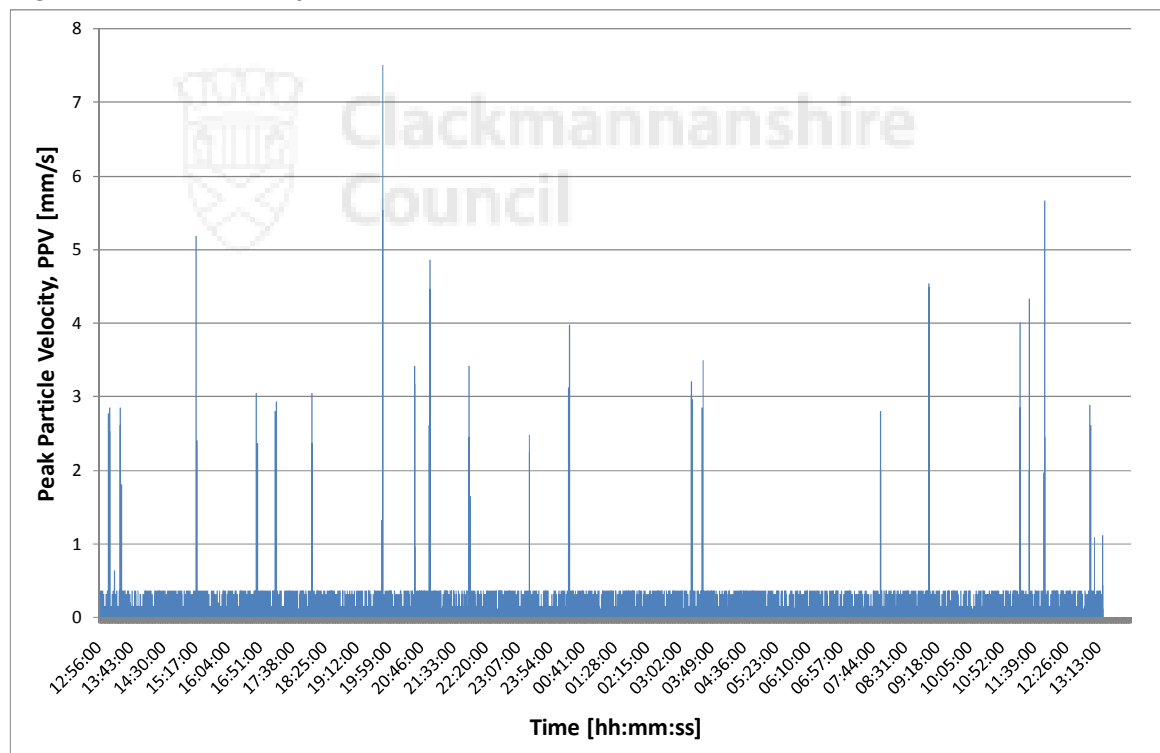
- 5.106 Winds of near gale force are likely to have occurred throughout the measurement period. There is unlikely to have been any precipitation.
- 5.107 Figure 5.53 shows the time history of the measured PPVs. A series of 23 prominent peaks can be seen. Each of these is expected to correspond with a train pass-by. It can be assumed that at least 23 trains passed the site. There is no evidence of any other sources of vibration. Of all the measured data, this set provides the clearest and most unfettered insight into train-induced vibration.

Figure 5.53: Time History of 30-Second PPVs Measured at 16 Ochil View, Kincardine

- 5.108 The highest measured PPV was 7.51 mm/s, which is unusually high. This level occurred between 19:48:00 and 19:48:30 on Wednesday 17th November. With reference to the discussion in 5.103, it is clear that train-induced vibration might give rise to cosmetic cracking. The risk of more severe ('minor' or 'major') structural damage is remote..
