Location 4: 16 The Sheilings, Cambus

Location 5: 8 Alloa Road, Cambus

Location 6: The Gables, Cambus

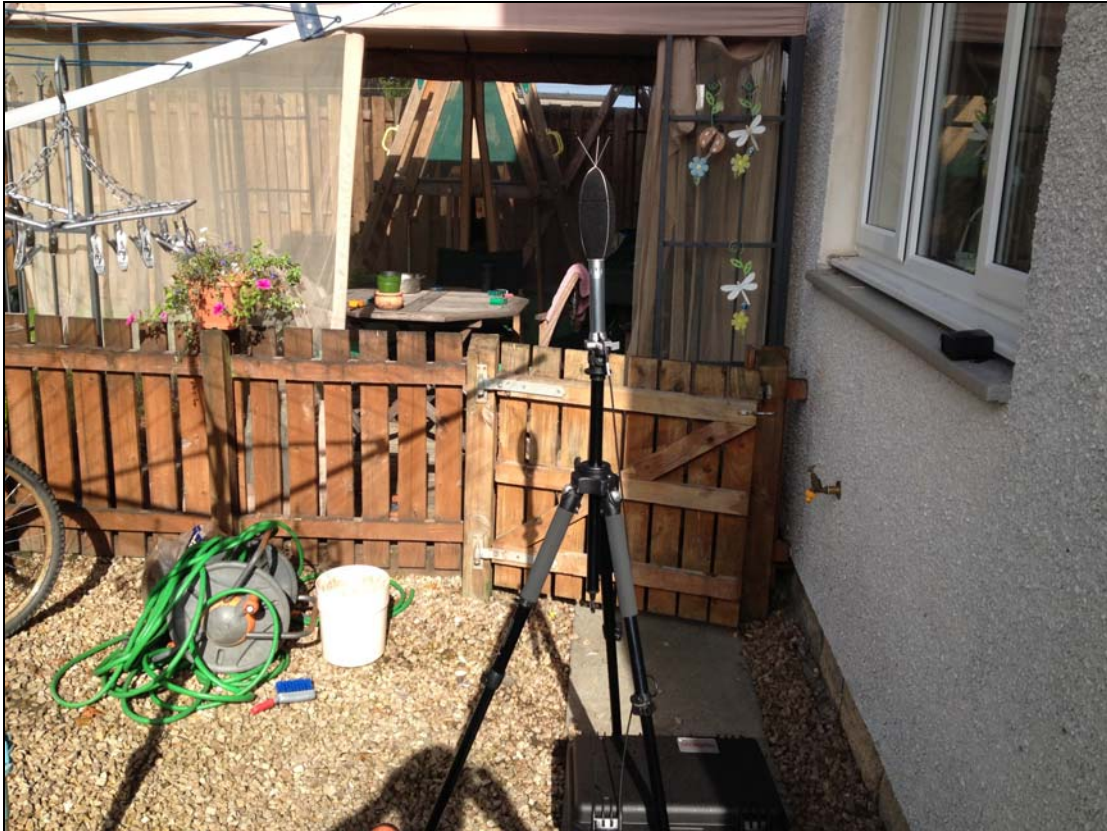
Photograph A.4: Measurement Location at 16 The Sheilings

The Brüel & Kjær 2250/2260 sound level meter was secured to a tripod with the microphone 1.5m above the ground, adjacent to the Rion NL-52/Brüel & Kjær 2250 sound level meter. The monitoring equipment was calibrated both before and after the measurement period using an acoustic calibrator, which has itself been calibrated against a reference set traceable to National and International Standards. There was no shift greater than 0.2 dB in the observed calibration level. Fifteen minute snapshot noise level measurements were undertaken with the Brüel & Kjær 2250 throughout the measurement procedure and are shown in Table A.4.

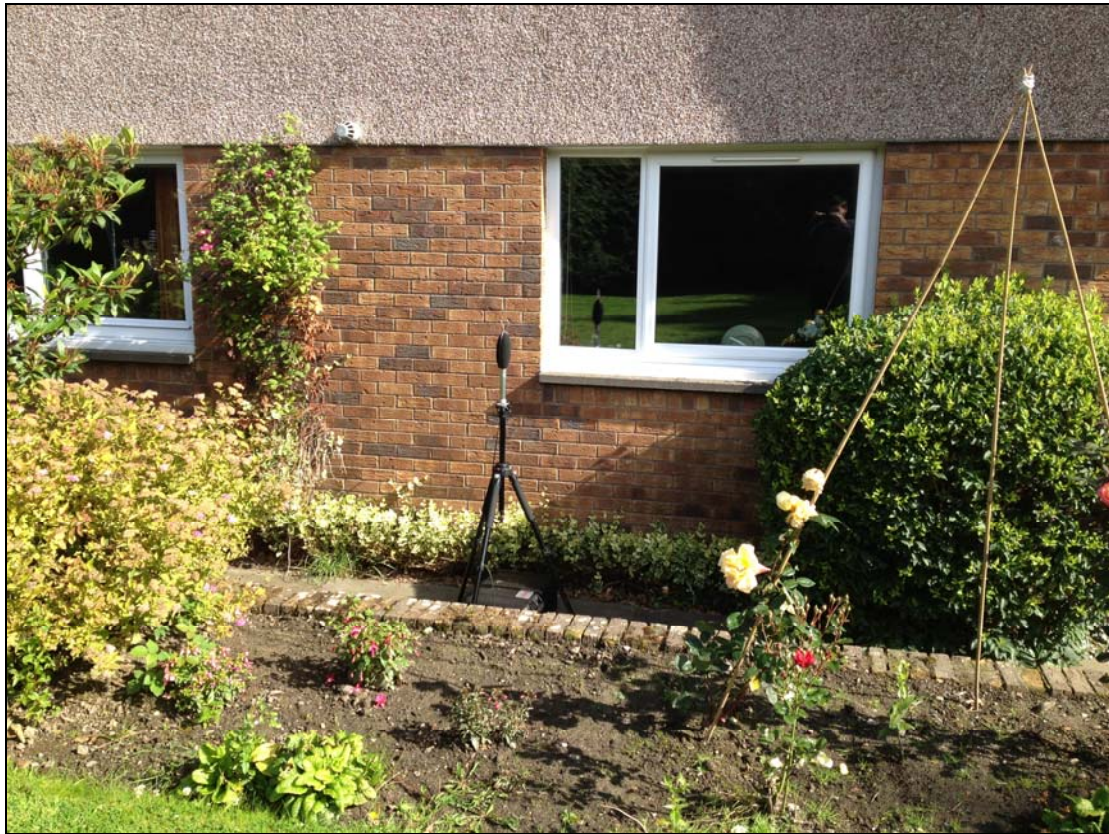
Photograph A.5: Measurement Location at 8 Alloa Road

The Brüel & Kjær 2250/2260 sound level meter was secured to a tripod with the microphone 1.5m above the ground, adjacent to the Rion NL-52/Brüel & Kjær 2250 sound level meter. The monitoring equipment was calibrated both before and after the measurement period using an acoustic calibrator, which has itself been calibrated against a reference set traceable to National and International Standards. There was no shift greater than 0.2 dB in the observed calibration level. Fifteen minute snapshot noise level measurements were undertaken with the Brüel & Kjær 2250 throughout the measurement procedure and are shown in Table A.5.

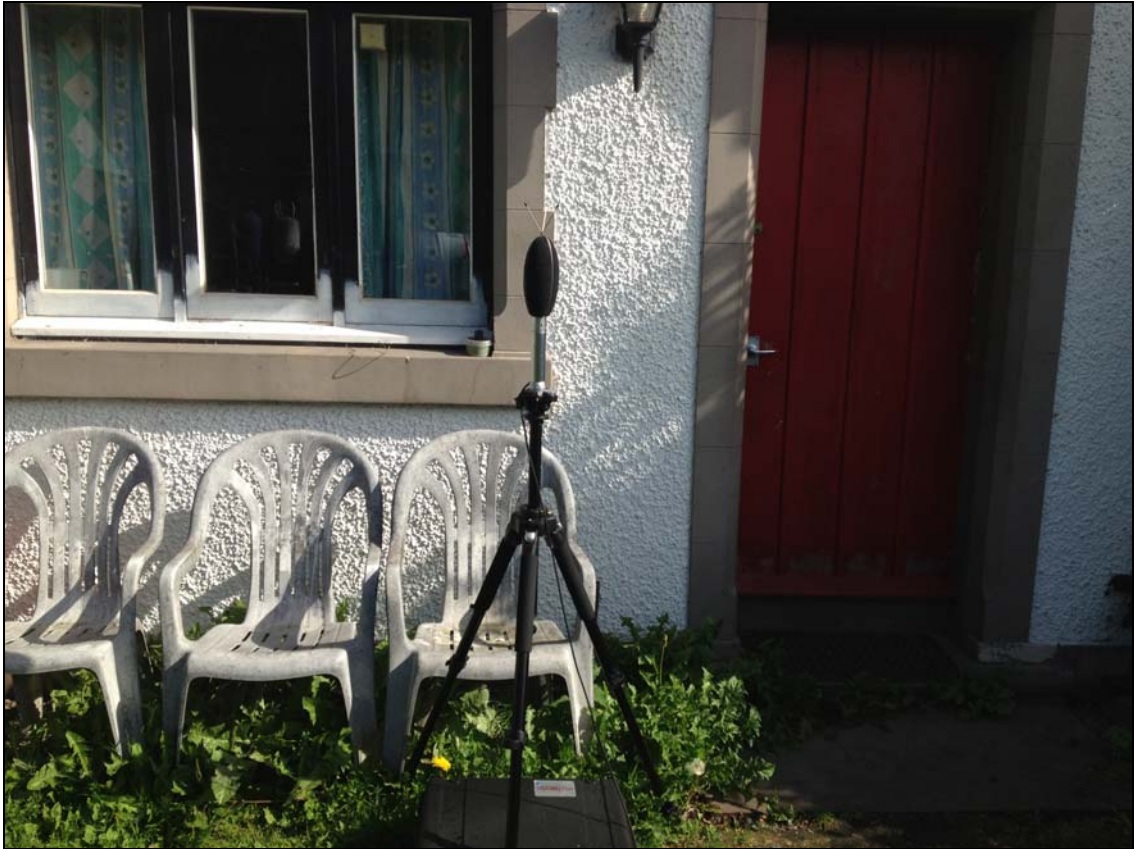
Photograph A.6: Measurement Location at The Gables

The Brüel & Kjær 2250/2260 sound level meter was secured to a tripod with the microphone 1.5m above the ground, adjacent to the Rion NL-52/Brüel & Kjær 2250 sound level meter. The monitoring equipment was calibrated both before and after the measurement period using an acoustic calibrator, which has itself been calibrated against a reference set traceable to National and International Standards. There was no shift greater than 0.2 dB in the observed calibration level. Fifteen minute snapshot noise level measurements were undertaken with the Brüel & Kjær 2250 throughout the measurement procedure and are shown in Table A.6.

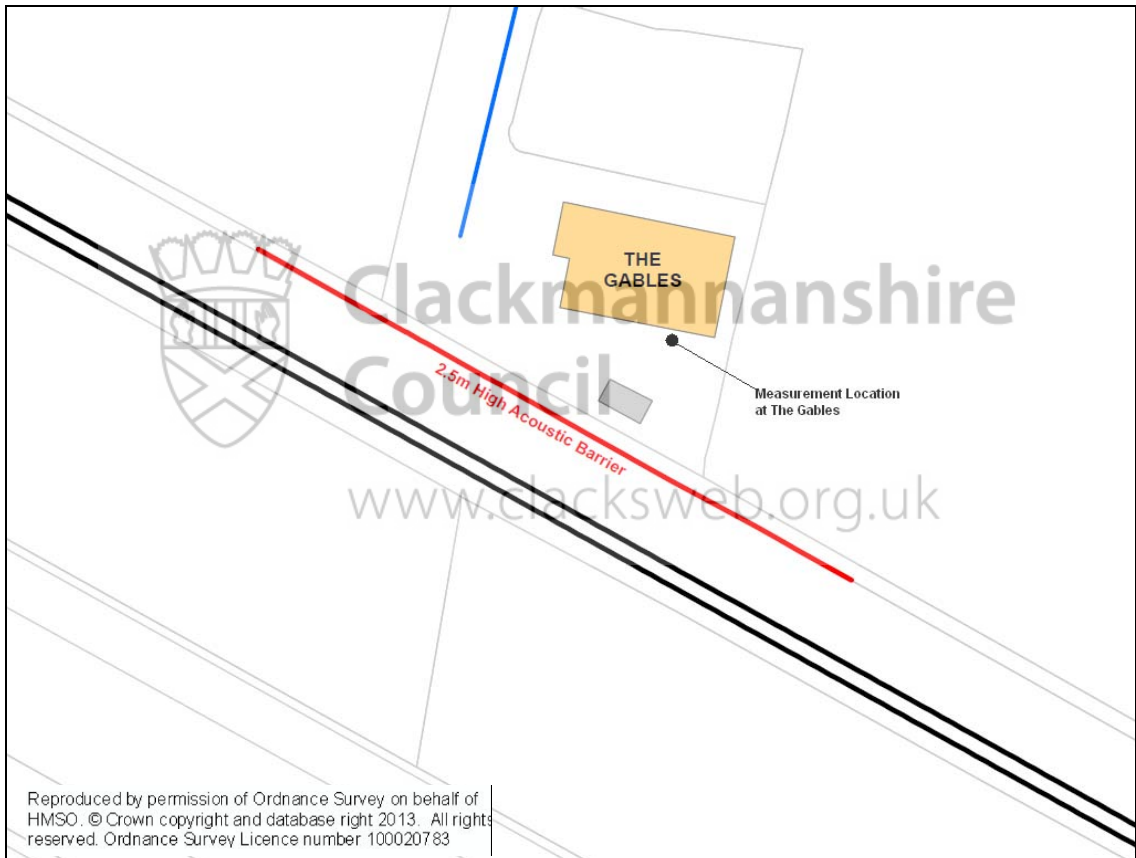
Figure A.6: Measurement Location at The Gables

The measurement position was located 1m from the southern facing façade, within the rear garden area of the property. This position in turn was approximately 16m from edge of the railway line as shown in Figure A.6. The Rion NL-52/Brüel & Kjær 2250 sound level meter was secured within a weatherproof box with the microphone positioned 1.5m above the ground, see Photograph A.6. The noise monitoring equipment was calibrated both before and after each measurement period using an acoustic calibrator, which has itself been calibrated against a reference set traceable to National and International Standards. There was no shift greater than 0.2 dB in the observed calibration level. The sound level meter was secured at the property and left continuously logging throughout the measurement period.
