# Menstrie Burn Post Flood Study

Summary Report

May 2013

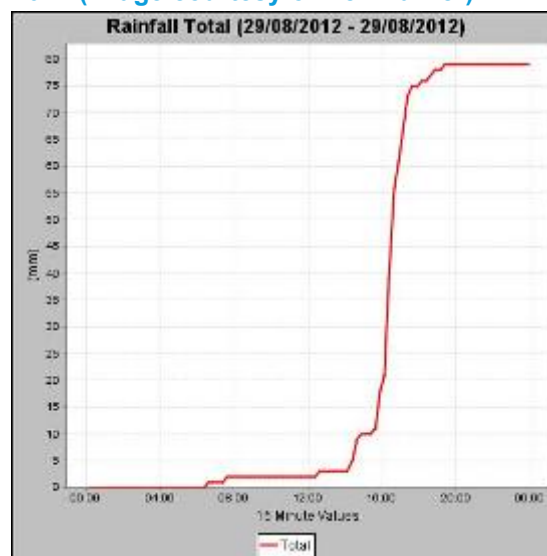
Bridge of Allan rainfall chart for 29-August 2012 (image courtesy of Ken Turner)

- Rainfall for the months of July and August were well above average, suggesting that the catchment was saturated prior to flooding.
- Locally gathered evidence suggests that the cause of the flood was a very localised, high intensity rainfall event, witnessed in the catchment and recorded in Bridge of Allan.
- Bridge of Allan experienced a high intensity rain storm on 29 of August. In just 2 hours 64mm of rain water fell. This has an estimated return period of 1,000+ years.
- It is assumed that the same storm which occurred over the Bridge of Allan also occurred and moved eastwards over the Ochils and into the Menstrie Burn catchment area.

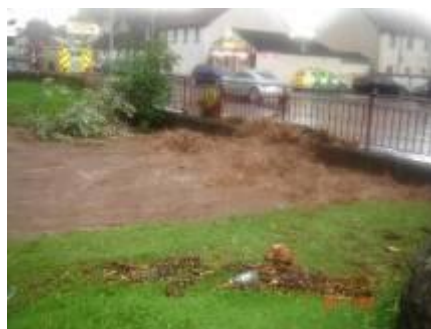
- The first exit point was on the **upstream face of the A91 Road Bridge**. The majority of water flooding onto the Main Street West from upstream of the road bridge travelled south west across Menstrie, following the road layout and impacting several properties; flooding gardens and premises. Flows entered Abercrombie Place, and probably also Windsor Street directly from Main Street. This water eventually ended up flooding Dumyat Road, Craigomus Crescent and Willow Grove, before following flow paths down towards Hazel Avenue.

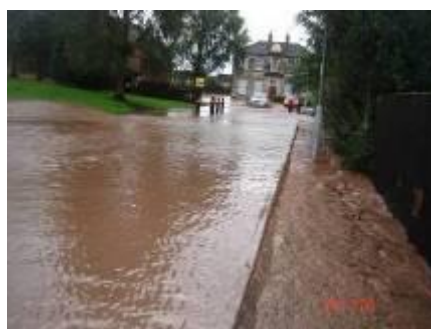
- Downstream of the pub, **water overflowed the bank and into the care home site**. A flow path developed onto The Charrier and combined with flows coming from Main Street West.
- Out of bank flows on the right bank were recorded along the block of houses at the end of **The Charrier (between houses 29 to 33)**. This water flooded properties in The Charrier and ended up on Burnside Road. Once on Burnside Road the water flowed into Craigomus Crescent and down Dumyat Road. Flood water also flowed south, crossing Burnside Road and through the properties into Pine Crescent, where it found its way into the surface water drainage network.
