5 Rail Vibration Measurement Results and Assessment

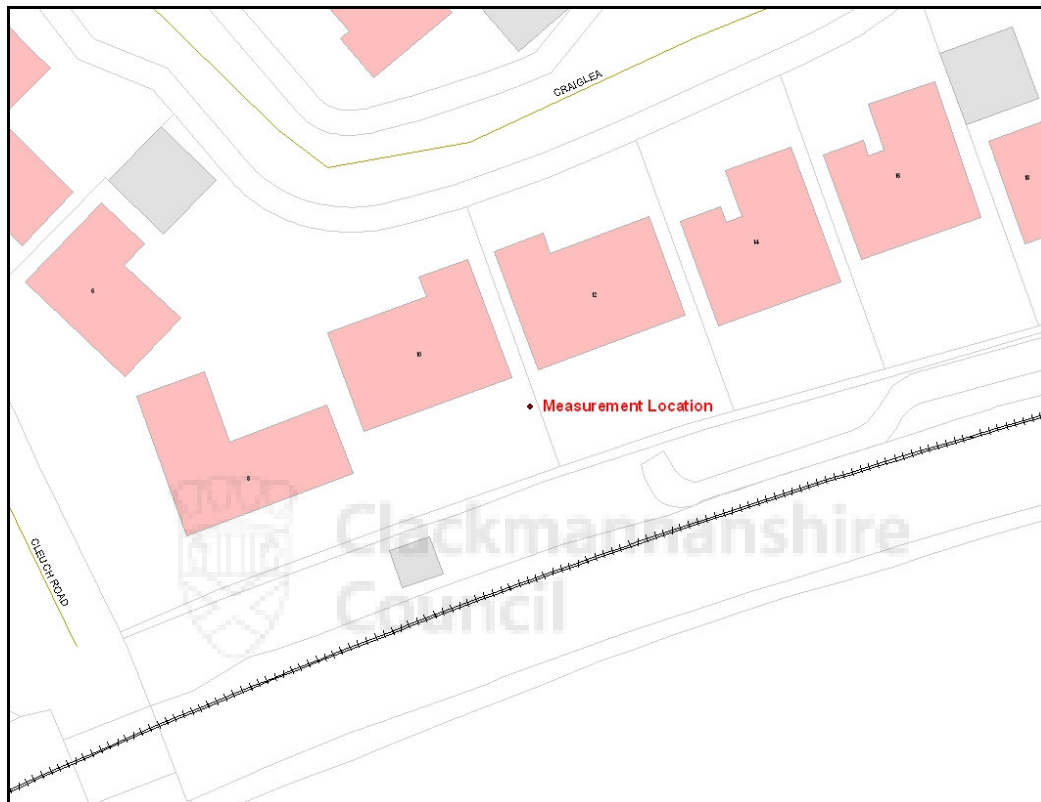
Figure 5.2: Plan of Measurement Location at 10 Craiglea, Causewayhead

- 5.6 The measurement transducer was located approximately 12 m to the north of the nearside of the SAK Railway line and approximately 4 m to the south of the façade of 10 Craiglea. Figure 5.3 shows the equipment with the dwelling to the left.

- 5.9 The highest measured PPV was 1.807 mm/s. This level occurred between 14:51:00 and 14:51:30 on Wednesday 24th November. It is likely to have resulted from the passage of a freight train.
- 5.10 The measured PPVs are well below the criteria in BS 7385. This is even when it is assumed that dynamic magnification occurs, as described in 3.6. It is therefore unlikely that cosmetic structural damage to the dwelling might result (or might have resulted) from train pass-bys. The likelihood of more profound structural damage is very low. Any apparent structural damage, such as cosmetic cracks not previously reported in 2005, is unlikely to have resulted from rail vibration.

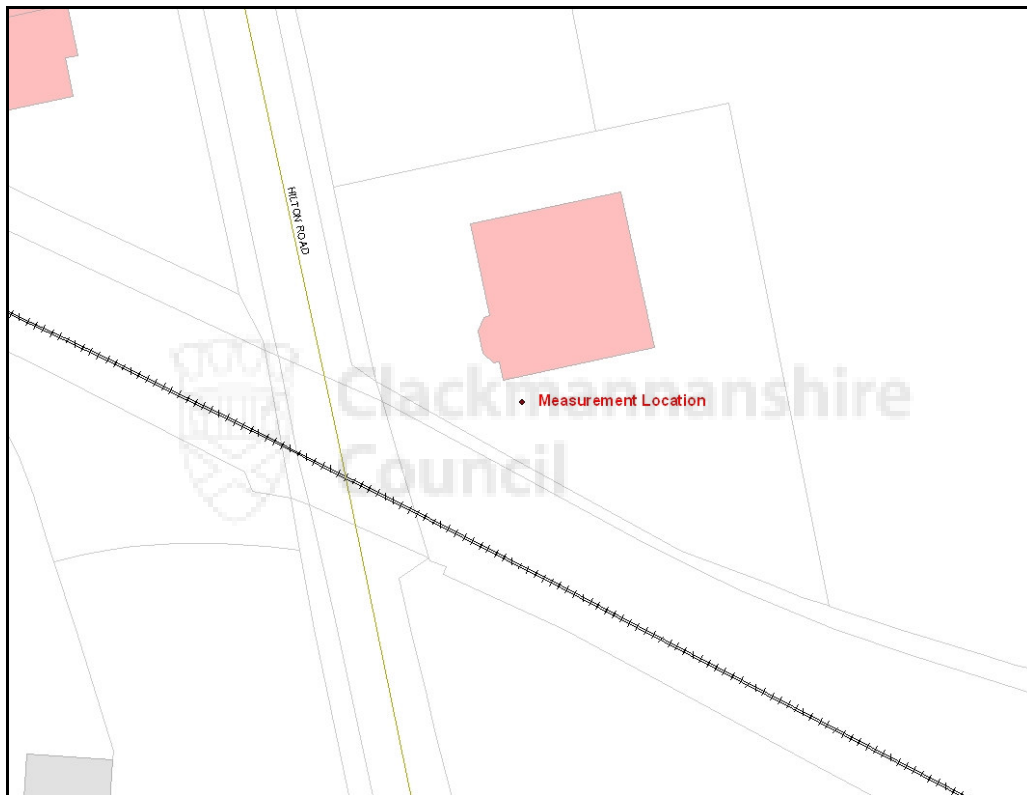
Figure 5.5: Plan of Measurement Location at Colum-Cille, Hilton Road, Alloa

- 5.13 The measurement equipment was located approximately 11 m to the north of the nearside of the SAK railway line and approximately 3 m to the south of the facade of Colum-Cille, Hilton Road. Figure 5.6 illustrates.

- 5.16 The highest measured PPV was 0.924 mm/s. This level occurred between 09:26:30 and 09:27:00 on Monday 22 November.
- 5.17 The measured PPVs are well below the criteria and are therefore unlikely to give rise to structural damage of any kind.

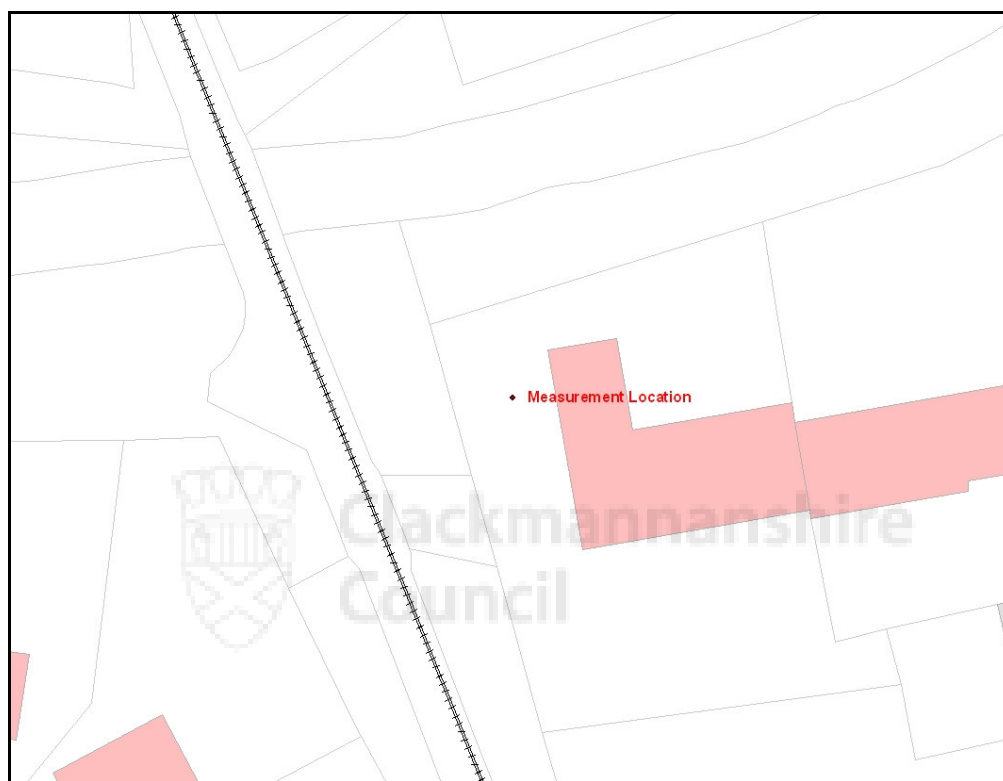
Figure 5.8: Plan of Measurement Location at 4 Mill Road, Clackmannan

- 5.20 The measurement equipment was located approximately 14 m to the east of the nearside of the railway track and approximately 4 m to the west of the facade of 4 Mill Road. Figure 5.9 illustrates.
