### 20 Ladywood, Clackmannan, Clackmannanshire

### 18 Ladywood, Clackmannan, Clackmannanshire

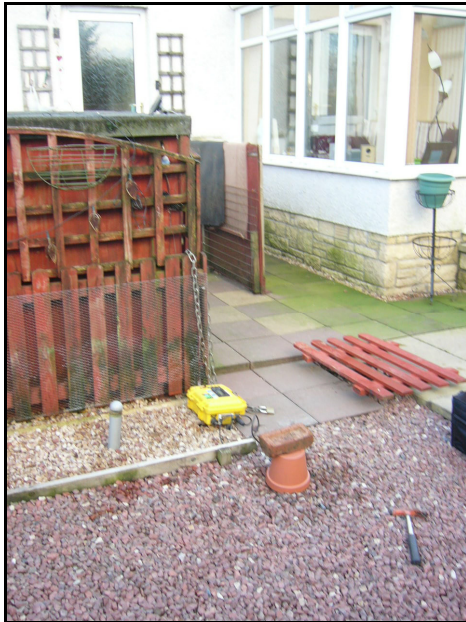
**Figure 5.27: Photograph of Vibration Monitoring Equipment at 30 Ladywood, Clackmannan**

- 5.57 The weather conditions during the measurement period are believed to have been generally dry with very light winds. There may have been a light ground frost during the night.
- 5.58 Figure 5.28 shows the time history of the measured PPVs. The spacing and relative magnitude of the most significant peaks suggest these were not caused by rail traffic. The highest levels are not consistent with a distance of 36 m to the railway. Levels at 20 Ladywood, at 41 m from the railway, are orders of magnitude lower. It is therefore reasonable to conclude that the significant levels were caused by spurious events such as the attention of children, household pets or tampering. This means that the data is inconclusive.

5.59 The dataset, which is contaminated by spurious events, provides no reliable indication of the PPV from train pass-bys. Vibration from train events can therefore not be assessed with respect to the criteria. Some indication of the likelihood of excessive levels is however provided by the dataset for 20 Ladywood, which shows PPVs below 0.5 mm/s. The risk of adverse structural effects due to vibration is therefore remote.

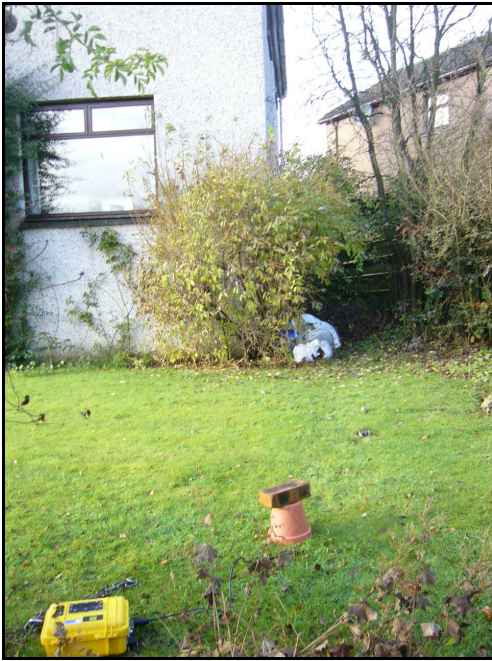
**Figure 5.30: Photograph of Vibration Monitoring Equipment at 20 Ladywood, Clackmannan**

5.62 The measurement equipment was located approximately 41 m to the south of the nearside of the SAK railway track and approximately 7 m to the east of the facade of 20 Ladywood. Figure 5.30 illustrates.

- 5.63 The weather conditions during the measurement period are believed to have been generally dry with a fresh breeze. During the night-time period it is possible that there was a light ground frost.
- 5.64 Figure 5.31 shows the time history of the measured PPVs. A series of peaks are seen to rise just above the noise floor of the measurement system. These slight increases in vibration are likely to represent the passage of freight trains.

5.65 The highest measured PPV was  $0.442 \text{ mms}^{-1}$ . This level occurred between 08:59:00 and 08:59:30 on Tuesday 23<sup>rd</sup> November. It is likely that this level represents the passage of a freight train. This level is well below criteria.

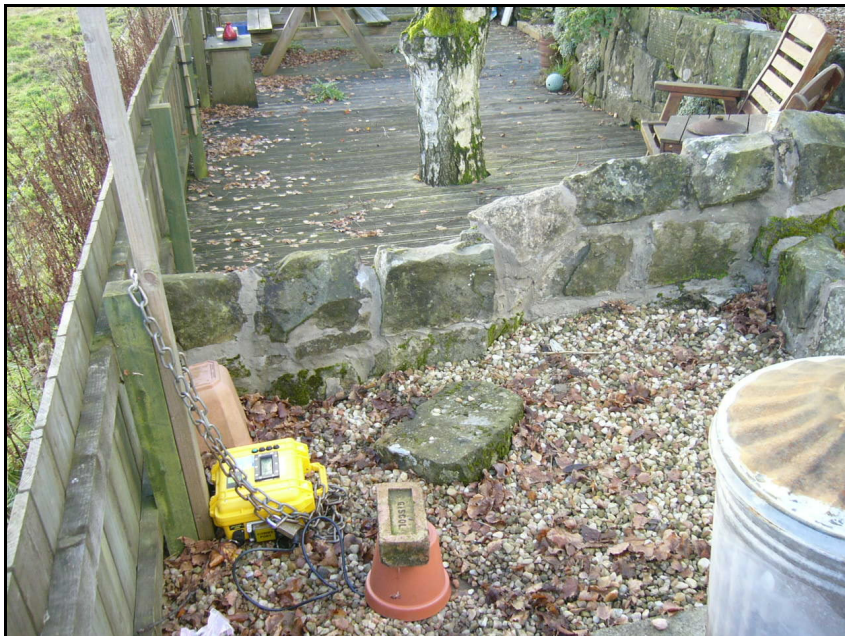
**Figure 5.34: Photograph of Vibration Monitoring Equipment at 18 Ladywood, Clackmannan**

5.68 The measurement equipment was located approximately 65 m to the south of the nearside of the SAK railway track and approximately 9 m to the east of the facade of 18 Ladywood. Figure 5.34 illustrates.

5.70 Figure 5.35 shows the time history of the measured PPVs. One event can be seen to exceed the noise floor of the measurement system. There is no pattern of regular train pass-bys, so there is little to support the notion that this level is caused by trains. It is most likely a temporary increase in system noise floor.

- 5.71 The highest measured PPV was 0.522 mm/s. This level occurred between 00:11:00 and 00:11:30 on Wednesday 24<sup>th</sup> November. This level, if caused by a train, would be well below the criteria. The possibility of structural damage of any kind is extremely remote.
